“Scaling up Experience in Improvement of Chemical Safety to
Contribute to Poverty Reduction in Rural Armenia” project
– Conference „10th Anniversary of the Stockholm Convention -
Tsakhkanadzor – May, 31th – 2011

POPs hot spots - evaluation of Arnika's research at 5 sites in Armenia

Jindrich Petrlik

Arnika – Toxics and Waste Programme

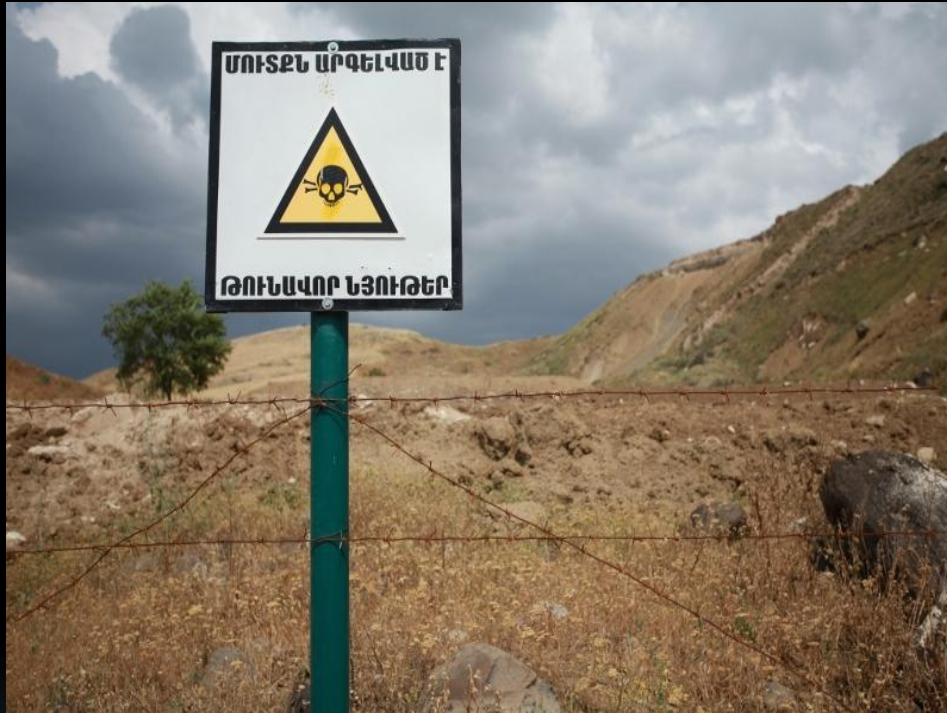
Results – Nubarashen - summary

- Down the slope the soil has been found to be heavily contaminated by DDT, HCHs, some **non-chlorinated pesticides (mainly simazine) and PCDD/Fs.**
- The levels found may pose a risk to human health and animals when present in this area.

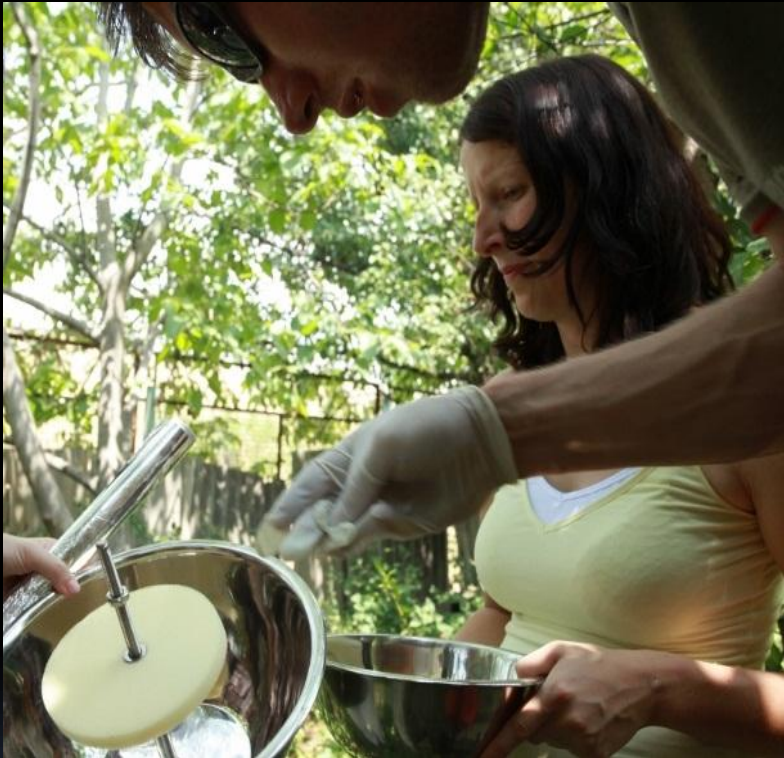
Results – Nubarashen - summary

- The very high air contamination determined at the fence of the burial site is significantly decreasing by distance, however, OCP concentrations are still significantly elevated up to 2 km distance from the site.

- Although the level of PCDD/Fs and dioxin-like PCB toxicity found in eggs sampled in Mushavan cannot be directly compared to legal standards, the high levels of TEQ suggest that these eggs are not suitable for consumption.

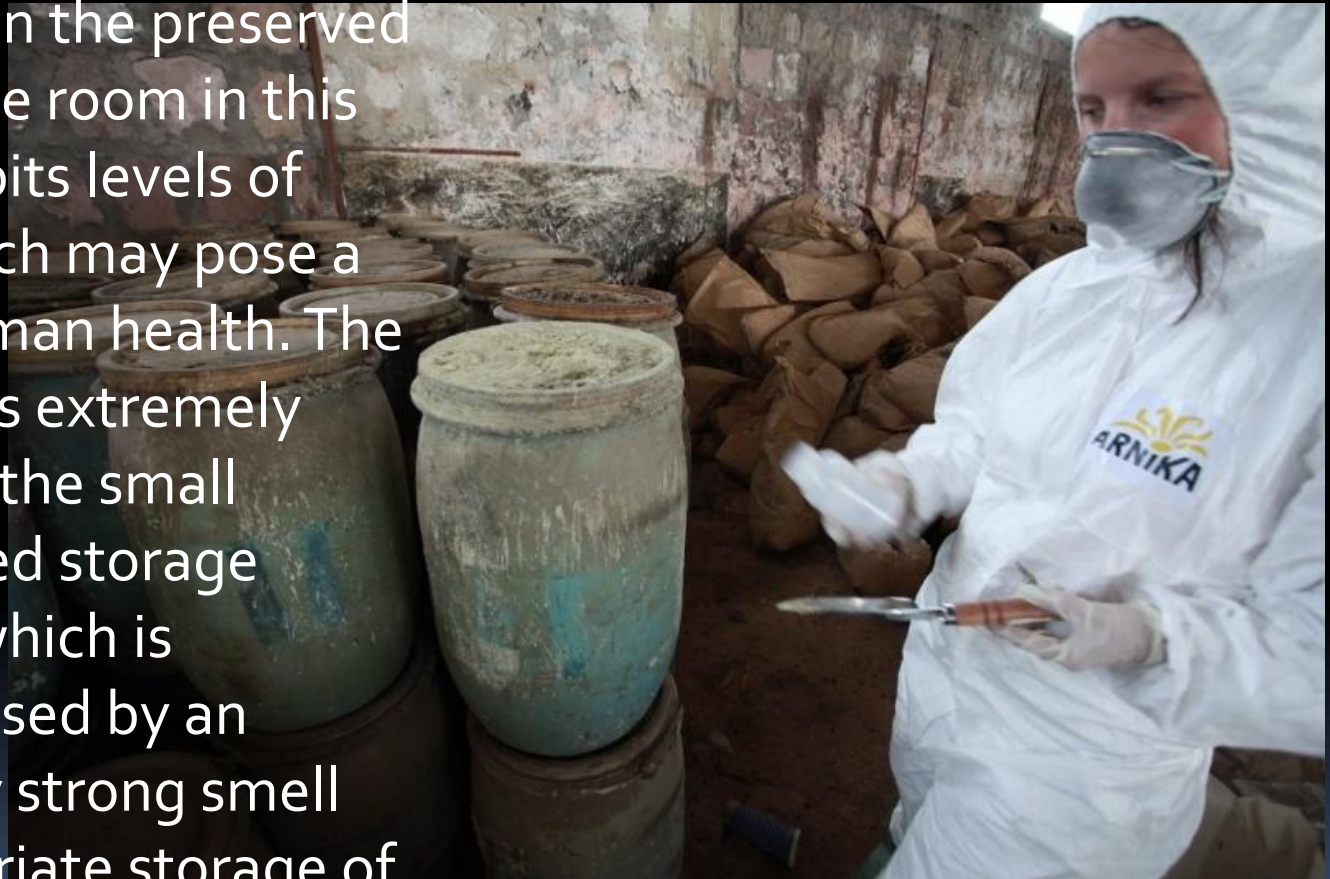
Results – Jrrarat - summary

- The floor in the preserved big storage room in this area exhibits levels of OCPs which may pose a risk to human health. The situation is extremely serious in the small demolished storage building which is characterised by an extremely strong smell (inappropriate storage of methyl mercaptophos).

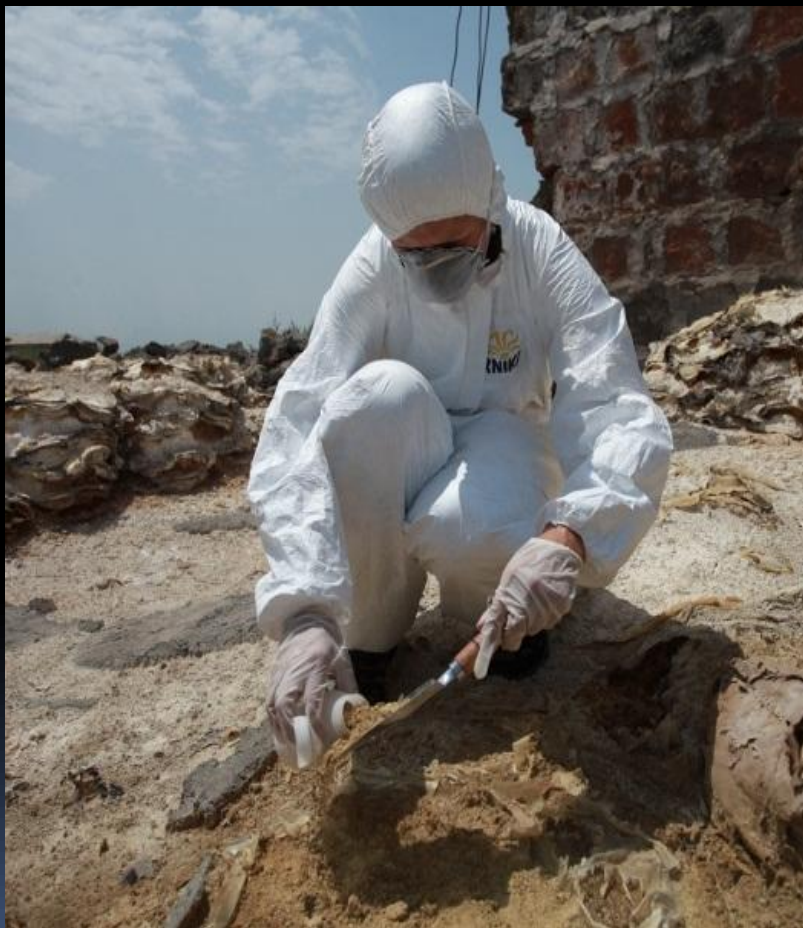
Results – Jrrarat - summary

- The soil between two demolished buildings is heavily contaminated by DDT as well as other OCPs and can be considered POP waste demanding appropriate clean-up measures.
- The spread of OCPs to the wider surroundings is reflected in the concentration gradient determined by passive air sampling and elevated DDT levels in free range chicken eggs sampled nearby.

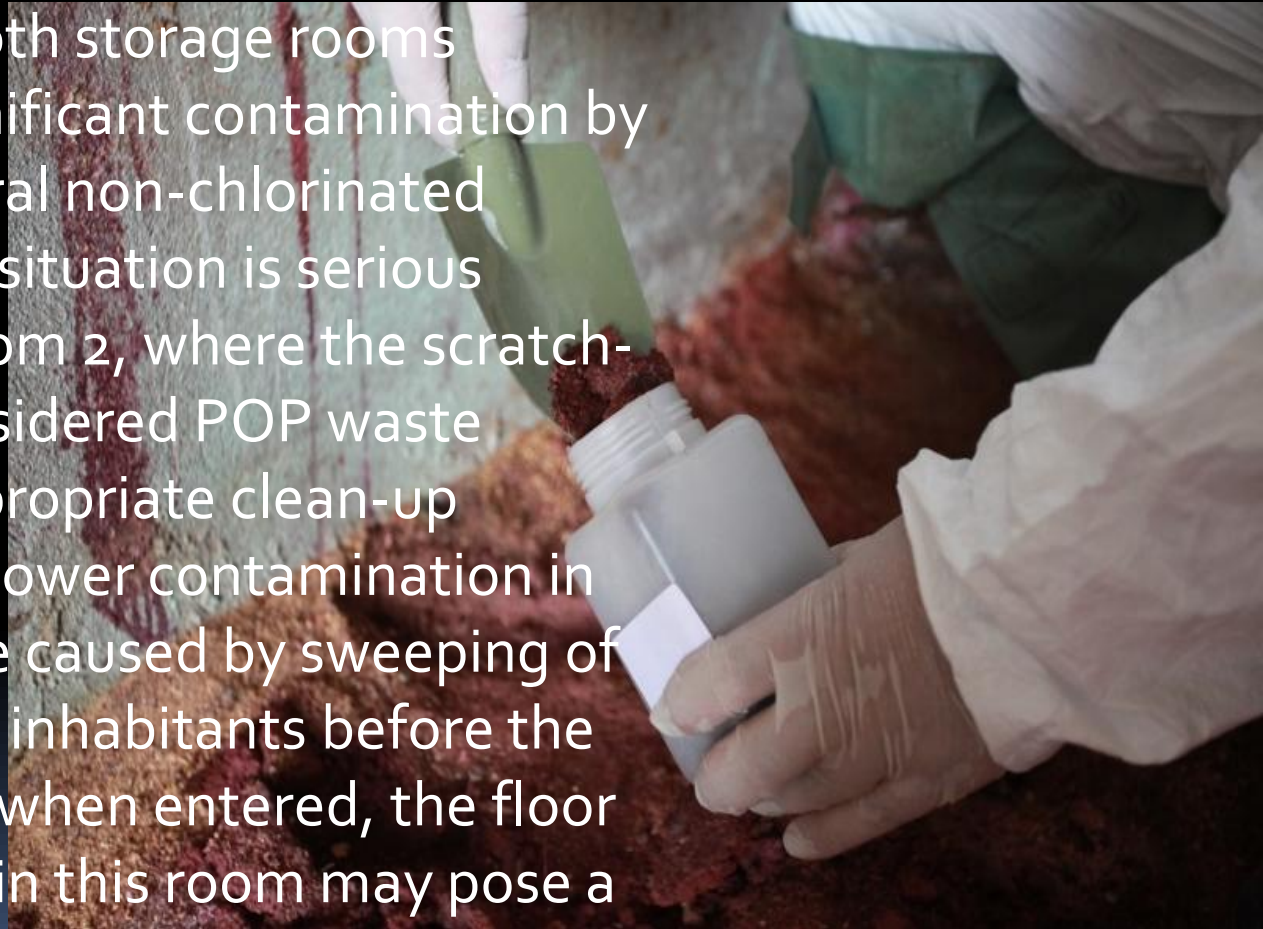
Results – Echmiadzin - summary

- The floors of both storage rooms exhibited a significant contamination by OCPs and several non-chlorinated pesticides. The situation is serious especially in room 2, where the scratch-offs can be considered POP waste demanding appropriate clean-up measures. The lower contamination in room 1 could be caused by sweeping of the floor by the inhabitants before the sampling. Still, when entered, the floor contamination in this room may pose a significant risk to human health especially due to a high PCDD/Fs-PCB TEQ.

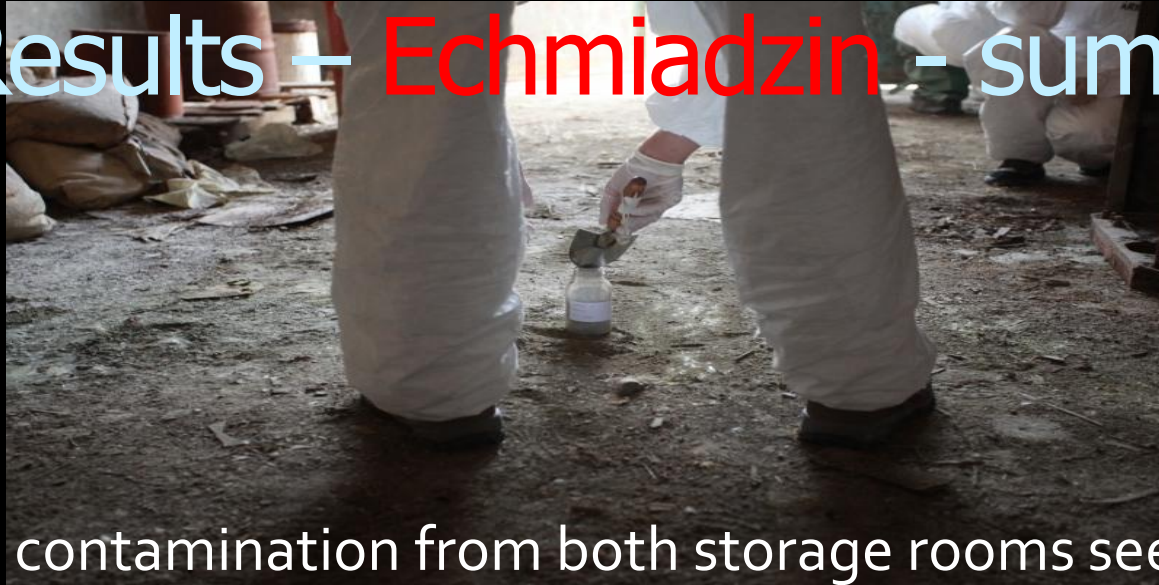
Results – Echmiadzin – summary

- The contamination from both storage rooms seems to spread out of the storage building (soil used to grow vegetable, the fish pond area cca 50 m far from the storage building is characterized by slightly elevated levels of DDT). The consumption of eggs sampled in close and wider surroundings of the storehouse which exhibited extremely high DDT concentrations is suspected to pose a significant health risk also due to high levels of PCDD/Fs and dioxin-like PCB toxicity.

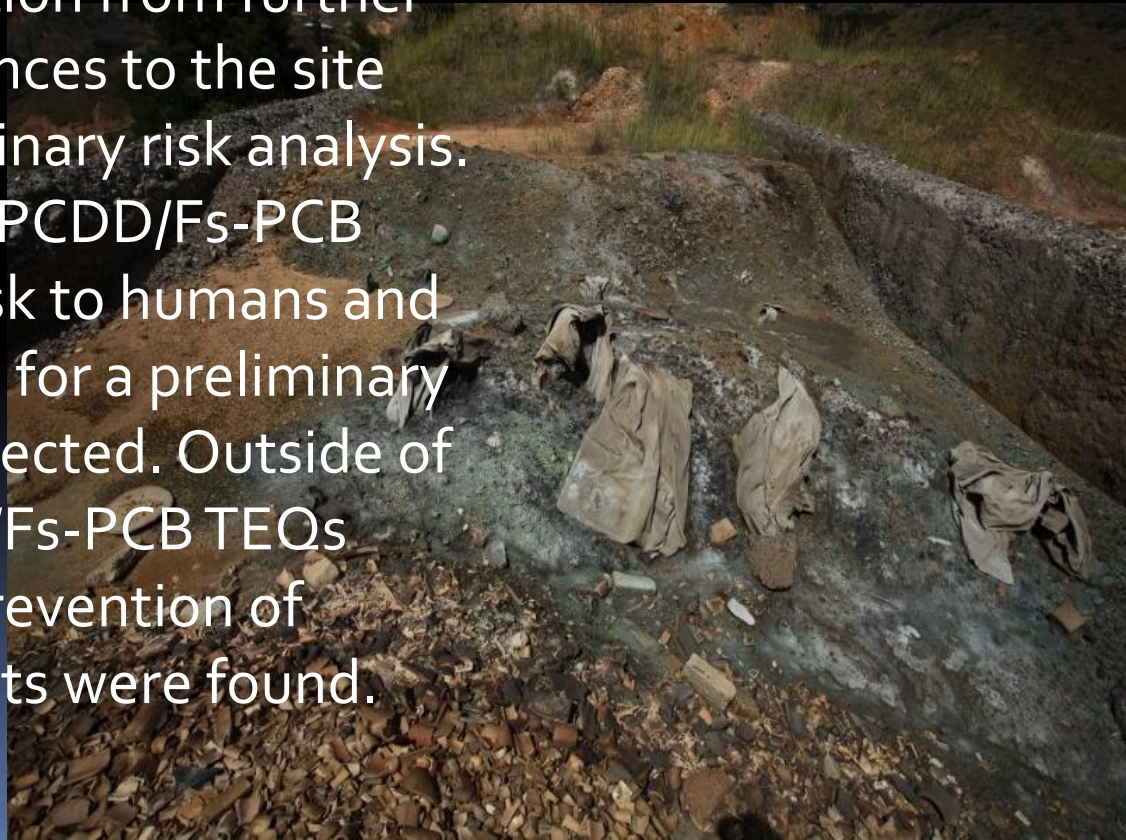
Results – Alaverdi - summary

- The production waste sediment in the middle concrete enclosure exhibited levels of concentrations of some OCPs demanding a prevention from further input of these substances to the site and a possible preliminary risk analysis. Inside the enclosure, PCDD/Fs-PCB TEQs suggesting a risk to humans and animals and the need for a preliminary risk analysis were detected. Outside of the enclosure, PCDD/Fs-PCB TEQs levels suggesting a prevention of further PCDD/Fs inputs were found.
